Manhole Inspection Summary

Manhole # S37QQ_028MH

Location Address: **2418 LOCH RAVEN RD** Cross Street: **BARTLETT AVE**

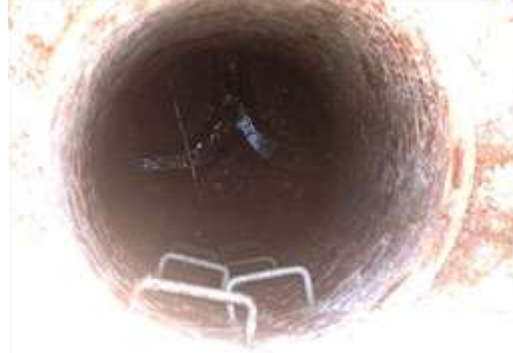
Top View

Steps Count: **6** Missing: **0** ☒ **Corroded**

Surcharge ☒ **Evidence Of Surcharge** Depth: **1.5** (ft.) ☐ Active Surcharge Present

Corroded steps. Evidence of surcharge - Bench debris. Channel debris.

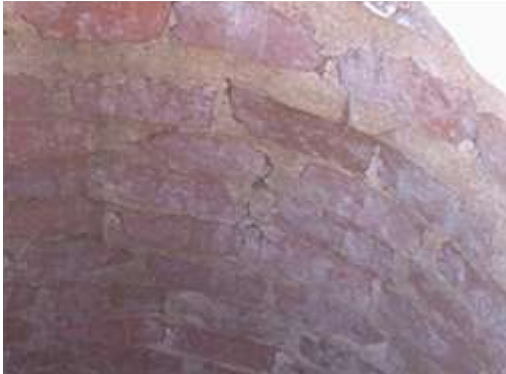
Defect

Chimney / Frame Adjustment ☒ Exists Material: **Brick** ☐ Parged Height: **6** (in.)
Condition: ☐ Sound ☐ Cracked ☐ Root Intrusion ☐ Loose Brick ☒ **Deteriorated**
Infiltration: ☐ None ☒ **Joint** ☐ Cracks ☐ Mortar ☐ Roots ☒ **Wall**

Corbel Material: **Brick** ☐ Parged Type: **Concentric/Eccentric**
Condition: ☐ Sound ☐ Cracked ☐ Root Intrusion ☐ Loose Brick ☒ **Deteriorated**
Infiltration: ☐ None ☐ Joint ☐ Cracks ☐ Mortar ☐ Roots ☒ **Wall**

Adjustment and Corbel deterioration and infiltration.

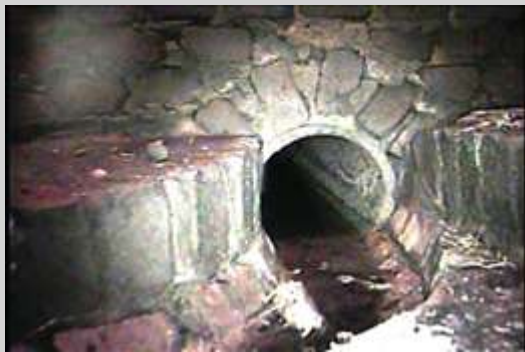
8 in. Circular Gravity Sewer Pipe Out @ 12 O'Clock

Barrel Material: **Brick** ☐ Parged
Shape: **Circular** Diameter: **46** (in.) Length: (in.)
Condition: ☐ Sound ☐ Cracked ☐ Root Intrusion ☐ Loose Brick ☒ **Deteriorated**
Infiltration: ☐ None ☐ Joint ☐ Cracks ☒ **Mortar** ☐ Roots ☒ **Wall**

Channel Material: **Brick** ☐ Parged ☒ **Debris** (not Condition related)
Channel Exposure: **Fully Open** Junc Dist: **0** nearest .5 ft. Azimuth:
Condition: ☐ Sound ☐ Cracked ☒ **Root Intrusion** ☒ **Deteriorated** ☐ Leaks ☐ Debris

Barrel deterioration and infiltration. Channel root intrusion and deterioration.

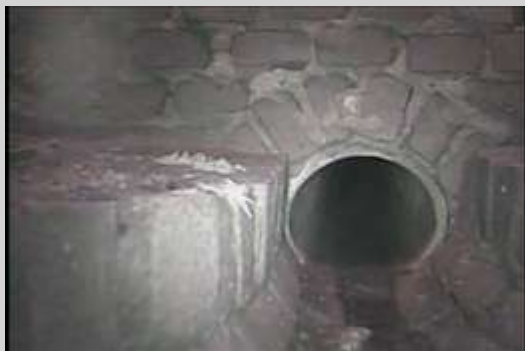
8 in. Circular Gravity Sewer Pipe In @ 3 O'Clock

Barrel deterioration and infiltration.

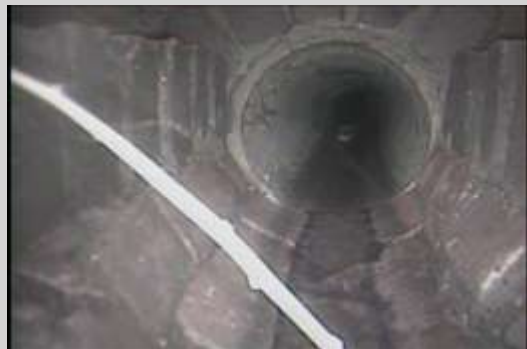
Pipe In @ 9 O'Clock

Channel deterioration.
